Soils and Foundations

# Lessons for countermeasures using earth structures against tsunami obtained in the 2011 Off the Pacific Coast of Tohoku Earthquake

Ken-ichi Tokida, Ryusuke Tanimoto

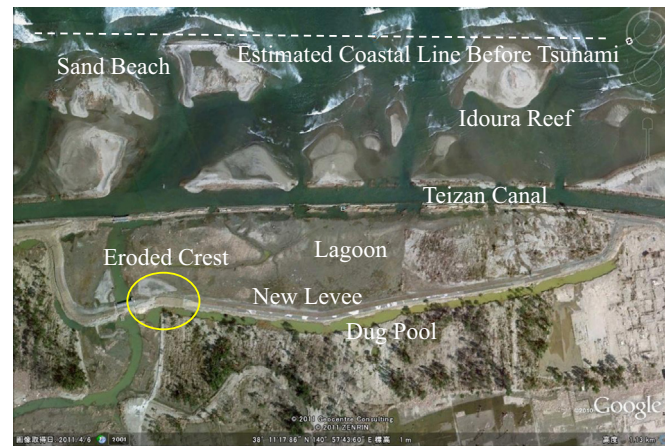
Photo 1. New river levee at Idoura on April 6.

Photo 1 is a satellite image of a levee newly constructed along the existing Teizan Canal at Idoura in the Wakabayashi

area of Sendai City. The new levee is approximately 3.9 m high and 1.5 km long and is located around a lagoon whose width is approximately 200 m. The purpose of this levee is to reinforce the Teizan Canal whose height is approximately 2 m. The photo shows that the coastal zone was washed away by the tsunami.

The levee, indicated by a circle in [Photo 1](#), is approximately 100 m long. It eroded and approximately a depth of 1 m of the crest was washed away by the concentration of tsunami flow. Nonetheless, the whole stability of the levee was maintained.

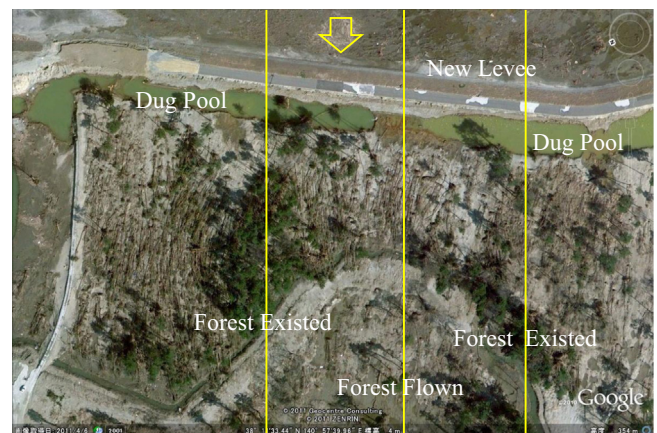
The dug pool shown in [Photo 5](#) is clearer in the satellite image in [Photo 6](#). It is seen that the forest located behind the dug pool was not completely washed away, but remained after the tsunami. On the other hand, it is interesting to note that the forest at the back side of the levee, where there is no dug pool, no longer exists; it was washed away by the tsunami flood-water. This observation on the difference in damage level of the forest represents an important lesson and implies that dug pools are effective in reducing the force of a tsunami.

Photo 6. Dug pool and forest on April 6 (Idoura).

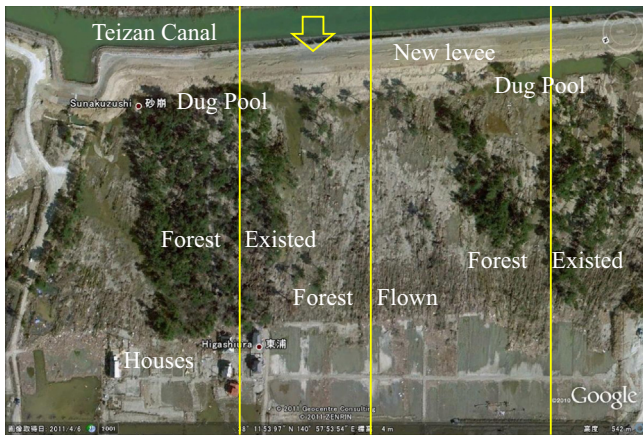
The levee at Higashiura, shown in [Photo 7](#), is located approximately 600 m from Idoura. It was also constructed to reinforce the Teizan Canal. In [Photo 7](#), dug pools can be seen at the back side of the levee; it should be noted that there are

levees with and without dug pools. A relationship similar to that for Idoura's site, between the existence of a dug pool and the forest damage, can be seen in [Photo 7](#).

Photo 7. Dug pool, forest and house on April 6 (Higashiura).

The remaining forest, shown on the left side of [Photo 7](#), is approximately 225 m long and 150 m wide. Several houses at the back side of this forest appear to be flooded to a depth of 3.5 m, but were not washed away, as shown in [Photo 11](#).

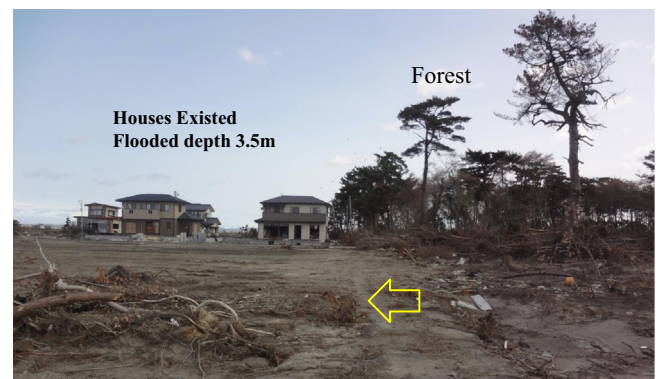
Photo 11. Residual houses at back of forest on April 30 (Higashiura).

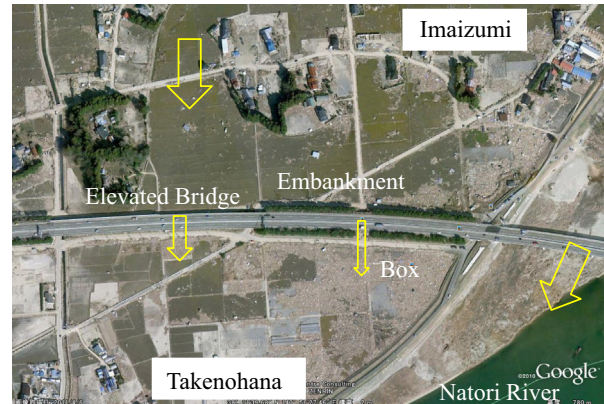
Photo 14. Overview of highway embankment on April 6 (Takenohana and Imaizumi).

As mentioned above, the embankment appears to be effective against the tsunami in this earthquake. However, the following three conditions should be confirmed for the case of future tsunami, because boxes, elevated bridges, and rivers (see [Photo 14](#)) are sensitive structures and most likely cannot effectively stop or reduce tsunami attacks.

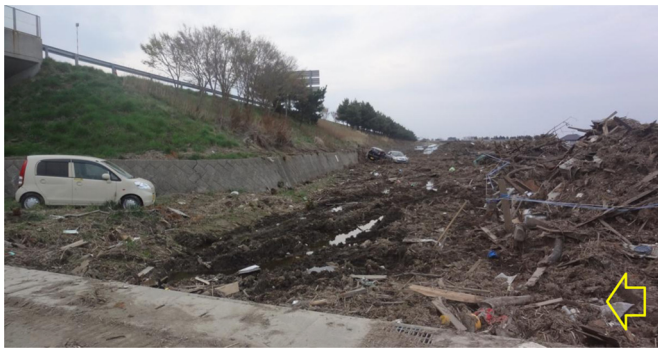
The Sendai Tobu Highway is mainly an embankment. [Photos 12](#) and [13](#) show the conditions around the embankment after the tsunami on April 30 at Takenohana and Imaizumi, respectively, which are located on the left side of Natori River, about 2.5 km from the river mouth on the mountain side and on the sea side, respectively.

Photo 13. View on sea side of embankment on April 30 (Imaizumi).

high with the slope toe reinforced with concrete blocks. The embankment was flooded, and the flooded depths measured at the sea side and the mountain side are 1.9 m and 1.15 m, respectively. The flooded height at the mountain side appears to be almost two thirds that at the sea side. In addition, the debris swept away on the sea side around the embankment, shown in [Photo 13](#), appears to be similar to or a little worse than that on the mountain side, as shown in [Photo 12](#).

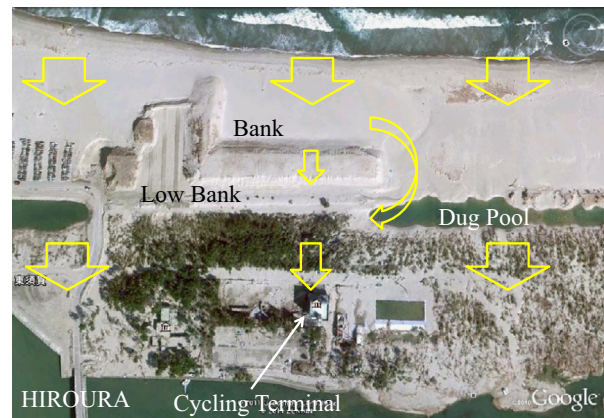
Photo 15. Temporary bank on beach after tsunami on April 6 (Yuriage).

At the sand beach, located on the east side of the Yuriage Fishing Port, a sand bank was found during the field survey on July 9. As shown in [Photo 15](#), this bank is approximately 5.6 m high and 150 m long; the crest is approximately 24 m wide and the front slope on the sea side is approximately 1:2.7.

On the basis of the field survey, the low bank shown in [Photo 18](#) is located at the boundary between the sand beach and the forest from the beach at Yuriage in Example 4 to the east-side beach of Sendai Airport. The dug pool with or without water, shown in [Photo 15](#), can be seen at the back of the low bank.

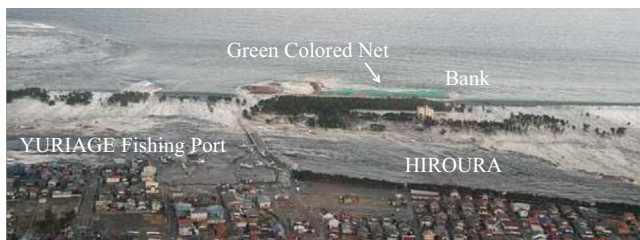
[Photo 16](#) ([Japan Coast Guard, 2011](#)) shows the bank just after the tsunami attack. It can be seen that the tsunami wave around the bank almost stopped and that the forest at the back side of the bank is flooded slightly. Although the objective of the bank, when it was newly constructed, was not to function as a countermeasure against tsunami, it was able to effectively resist the tsunami of March 11, as shown in [Photo 16](#). The photo also shows that the tsunami goes around both edges of the bank and into the forest, and that the flooded depth at the cycling terminal in the forest is approximately 4.3–5 m.

The existence of a green-colored net covering the bank, seen in [Photo 16](#), is verified in a satellite image before the earthquake on August 14, 2009. However, it appears that the net was not covered with surface soils when the tsunami struck. The field survey of July 9 revealed that the net was mostly swept away, but there were some pieces remaining. The crest of the bank was slightly flooded, and the estimated flooded depth is approximately 0.5 m (see [Table 1](#)). This estimate is based on two observations of the crest: (1) the remaining pieces of the net, and (2) the existence of a small 0.3-m-high pine tree.

Photo 16. Bank attacked by tsunami on March 11 (Yuriage).

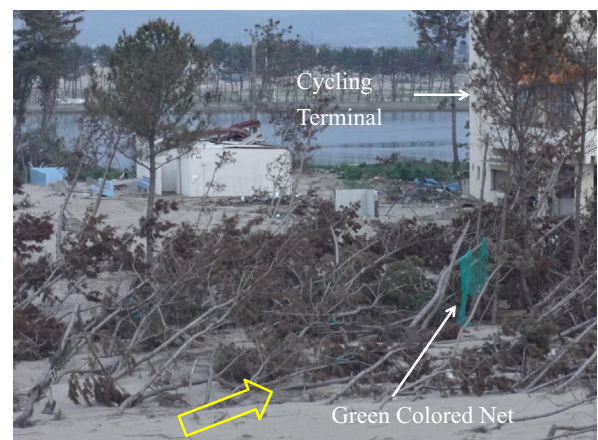
[Photo 19](#), which shows a view at the right edge of the bank shown in [Photo 15](#), reveals that trees had fallen in the direction

from the left side to the right side of the photo. This means that the tsunami went around the edge of the bank. The remaining net can also be seen in [Photo 19](#).

Photo 19. Trace of direction of tsunami flow on July 9 (Yuriage).

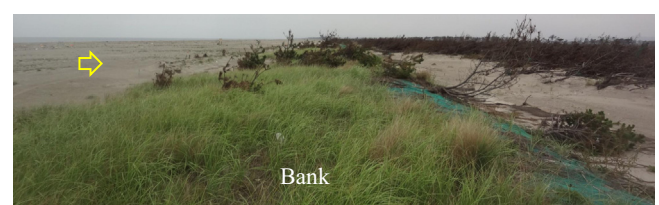
[Photo 20](#) shows a low bank located approximately 900 m from the bank of Example 4. A section of this bank is shaped like a triangle with a height of 1.5 m and front and back slopes of approximately 1: 7.3 and 1: 2.7, respectively. The slope surface is covered with grass and pine trees, as shown in [Photo 21](#). The surface layer is reinforced with nets installed to

Photo 21. Grass not eroded at front slope on September 11 (East Yuriage–East Airport).

approximately 0.3 m in depth. These nets appear effective in protecting the surface against tsunami-induced erosion.

As for the reinforcement methods of the banks against attacks by tsunami, Photo 21 indicates the effectiveness of the reinforcement using synthetic fiber nets.

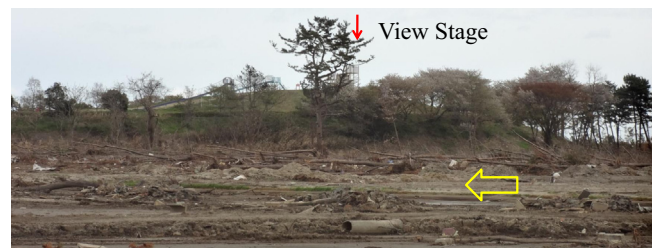
Photo 24. High bank at Boken Plaza on May 2.

An artificially made high bank was found in the Wakabaya-shi area of Sendai City. Field surveys were conducted at this site on May 2 and September 10. This high bank was constructed as a public ground for an adventure play named Boken Plaza in this paper and located approximately 350 m from the coastal line, as shown in Photos 23 and 24. The bank is shaped like a ship and is approximately 400 m long and 80 m wide. The top of the bank is located on the sea side and the bank is sloped to the west, i.e., the mountain side. With the aid of a plate set at the view stage, constructed on top of the bank, it was found that the height of the bank is 15.89 m. As the height at the top, measured from the surrounding ground

surface, is 14.9 m, the estimated flooded depth is 10.55 m; this is based on the flooded trace observed by the authors on the surface of the bank. Shibayama et al. (2011), however, reported that the flooded trace was 1.1 m below the top; and thus, the flooded depth was 14.79 m. For a height at the top of 14.9 m, a flooded depth of 13.8 m can be estimated.

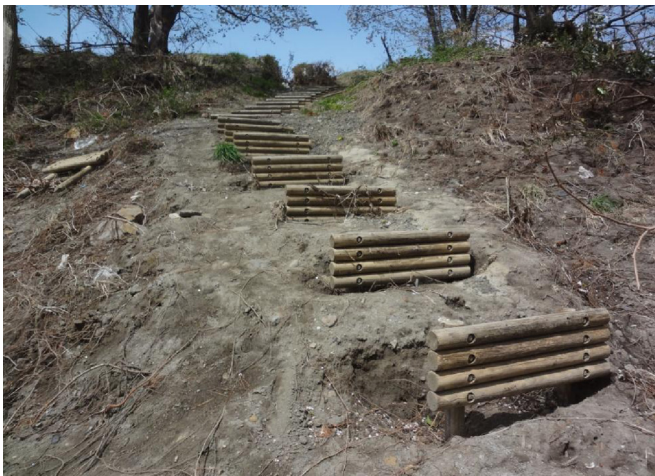
Photos 25 and 26 show the eroded conditions on May 2 on the side and at the front of the bank after the tsunami, respectively. The slopes of both sides are 1: 4–1: 5 and/or similar to the slope of the river levee; each side is eroded slightly. Photo 27 clearly shows the erosion of a walkway at the front of the bank. It is seen that the damage level is low and can be repaired easily; there is no geotechnical problem.

Photo 27. Steps on front slope in [Photo 26](#) on May 2 (Boken Plaza).

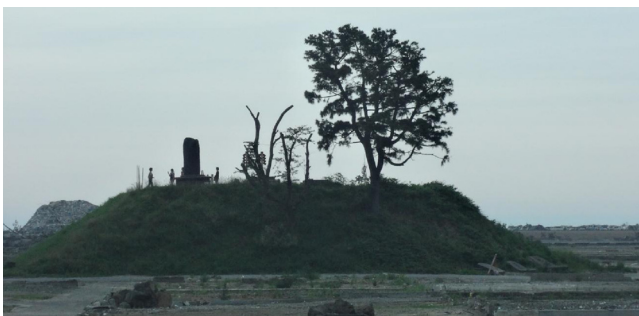
Photo 28. Hiyoriyama Hill from mountain side on July 9.

The Yuriage area of Natori City was severely damaged by the tsunami, as shown in [Photo 16](#). Mt. Hiyoriyama, located in the Yuriage area, can be referred to from the geotechnical engineering viewpoint. [Photo 28](#) shows Mt. Hiyoriyama, which appears as a small manmade bank. It is 6.55 m high and its top forms a flat  $12 \times 20 \text{ m}^2$  stage.

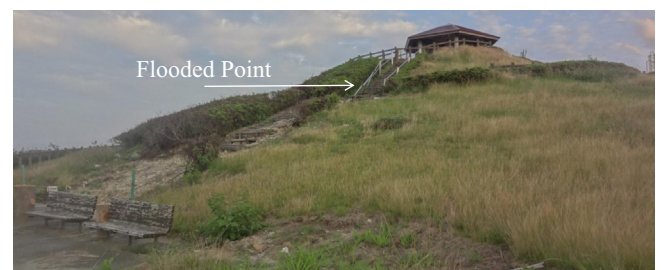
Photo 30. View stage at Iwanuma Coastal Green Zone on July 8.

A small manmade bank that acts as a view stage was found in the Iwanuma Coastal Green Zone close to the coast. [Photo 30](#) shows a view of this bank. It is 9.8 m high, the top is flat and circular in shape with a diameter of approximately 10 m, the front slope is 1: 2, and the back slope is 1: 4. Low trees are planted on the surface of the bank. On the basis of the tsunami

trace at the surface, the flooded depth was measured and found to be approximately 6.8 m. The tsunami did not flow over this bank and the erosion at the surface appears to be very small.

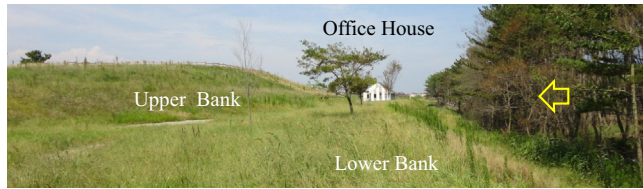
Photo 32. Slope on sea side on September 12 (Iwanuma Coastal Green Zone).

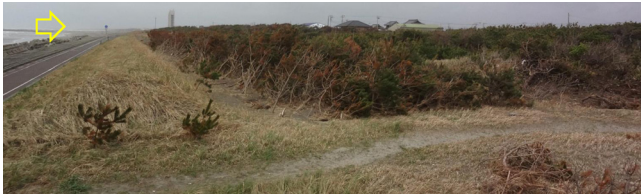
[Photo 36](#) shows the condition at the crest of the bank on April 23 and reveals that the crest was not eroded and the surface of the planted bank could be protected against the shallow overflow of about 0.5 m deep. [Photo 37](#) shows trees planted at the back side of the bank, these trees are tilted a little

Photo 37. Forest by low overflow on April 23 (East Ashikawahama).

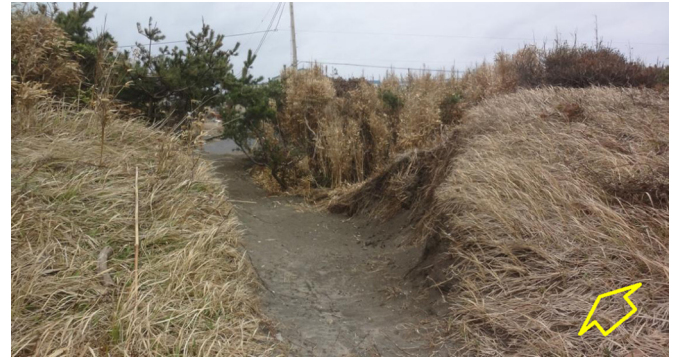
Photo 39. Pass crossing bank in Photo 38 (East Ashikawahama).

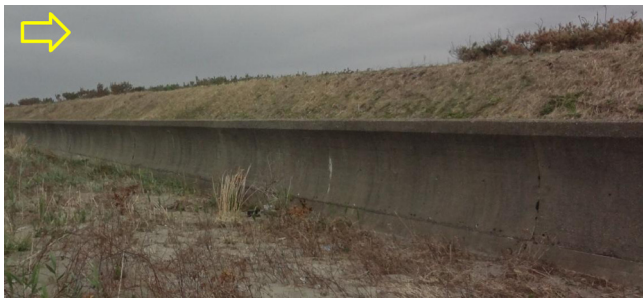
Photo 42. Vertical wall of sea wall at Mikawa on April 23.

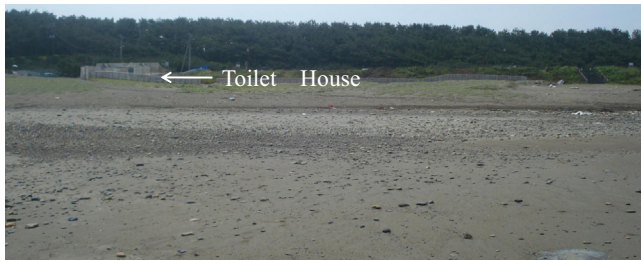
Considering the flooded traces by the tsunami shown in Photos 47 and 48, the run-up heights of the tsunami at Sites A and B were measured in the field survey and found to be approximately 9 m and 13.8 m, respectively. This indicates that the run-up height on the gentle slope was greater than that

Photo 47. Run-up height at Site A on June 4 (Oarai Coast).

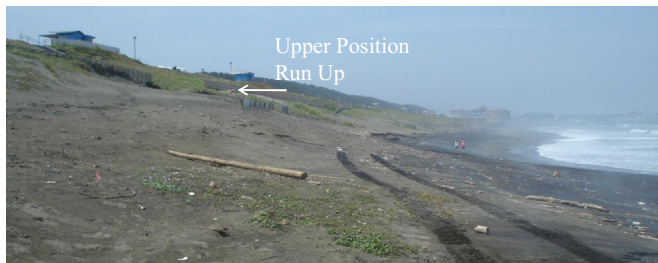
Photo 48. Run-up height at Site B on June 4 (Oarai Coast).

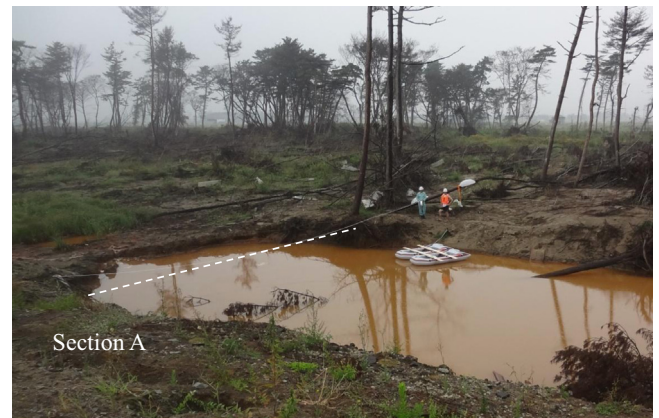
Photo 53. Field survey on dug pool at Idoura on September 11.

This investigation included measurements by static cone penetration tests and dynamic cone penetration tests. Soil samples were also taken around the dug pool. The layout of the tests and samples is shown in Fig. 7. A view of the site from the crest of the river levee is shown in Photo 53. The direction of this view is indicated in Fig. 7.

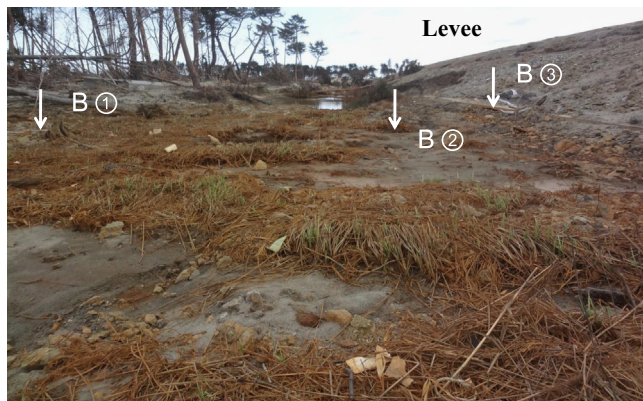
Photo 54 shows the ground surface at the back side of Section B and indicates that the ground surface is not severely

Photo 54. View of field survey at Idoura on May 2.

eroded. This is attributed to the existence of gravel soils and plants which cover the ground surface and render it a little harder than that at Section A. Detailed results on the dug pool at Idoura were reported by Tanimoto et al. (2011).

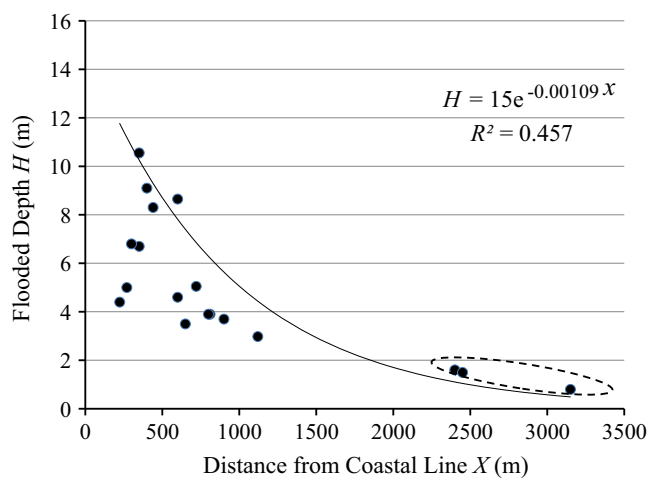
Table 4 shows the values for  $b$  and for the coefficients of correlation ( $R^2$ ) of Eq. (7) for different values of  $a$  in the range 10–5 m. It is seen for  $a=10$ –12 m, which is similar to the conditions in Fig. 10, that the flooded depth of 8–9 m is not consistent with the correlation line. However, for  $a=14$ –15 m, as shown in Fig. 11, the flooded depth at the sites far from the coast line is underestimated.

Fig. 11. Relation between  $X$  and  $H$  in case of  $a=15$ .

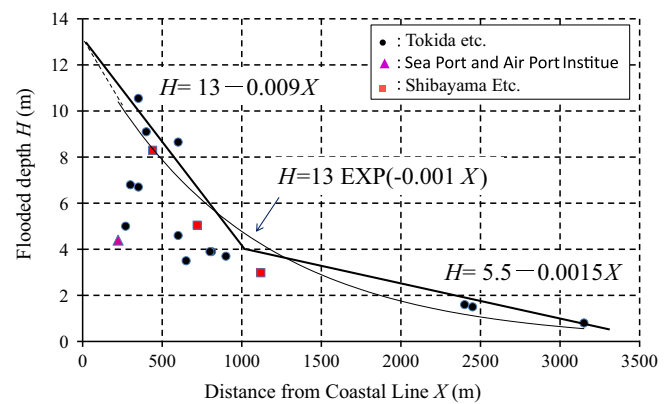
Therefore, a value of 13 for  $a$  is considered in this study and Eq. (8) is established; the correlation line representing Eq. (8) is shown in Fig. 12.

Considering a flooded depth at the coastal line of 13.0 m, the bi-linear relationship in Fig. 12 may be represented by Eqs. (9.1) and (9.2) as follows:

Fig. 12. Proposed relation between  $X$  and  $H$ .

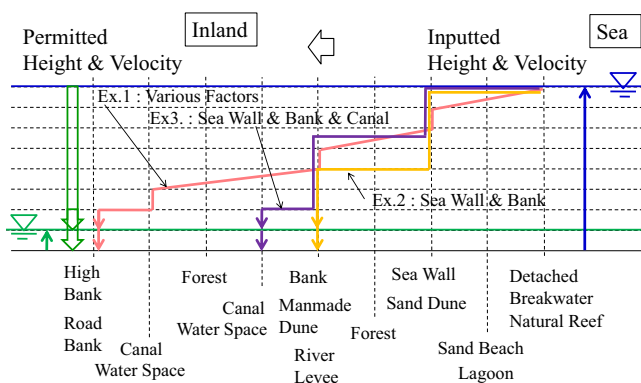
Fig. 13. Performance-based design concept combining factors related to reduction of tsunami.

When the reducing function of each structure can be quantitatively estimated, the performance-based design concept shown in Fig. 13 may be generally proposed. As shown in Fig. 13, the input conditions of the tsunami at the coastal line, such as the run-up height and the flow velocity, are gradually reduced through each reducing structure to output conditions such as the required flooded depth and flow velocity. The structures considered in the above design can be selected and 3 examples are shown in Fig. 13.

The corresponding structures in Examples 1 to 3 (showed Examples 1–3 in Fig. 13) are various structures, sea wall/bank, and sea wall/bank/canal, respectively. In other words, the combination of various reducing structures against the tsunami may be considered to represent a form of multiple defenses.

In order to apply the design concept shown in Fig. 13, further work is necessary to investigate and to quantitatively estimate the reducing function of the selected structures.

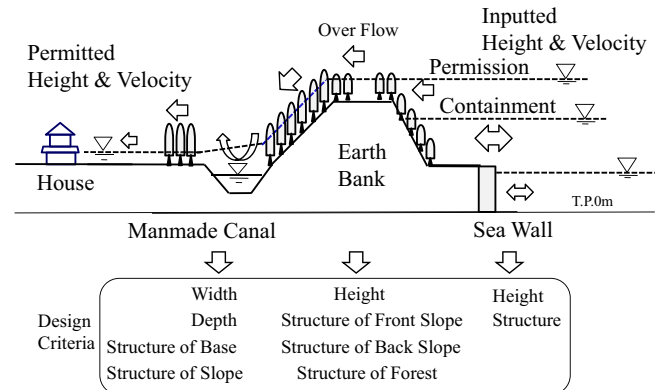
Fig. 14. Design concept against tsunami with sea wall, earth bank, and manmade canal.

In addition, considering the effects of the force reduction by earth banks, dug pools, and forests, as learned from the lessons in this paper, a combination of sea walls, earth banks with plants, and manmade canals can be proposed in case the tsunami overflow is permitted at the sea wall, as shown in Fig. 14 and/or Example 3 in Fig. 13; a manmade canal is constructed in advance instead of a dug pool. From the viewpoint of the performance-based design, each performance of the sea wall, the earth bank, and the manmade canal will be applied to reduce the depth and/or velocity of the tsunami flood to perform the Classes 1–3 in Table 6, and then the objective wooden houses located inland will be protected and not be swept away completely by future tsunami of Level 2.
